# Inventory Report

3 Windsor Road, [REDACTED],  
[REDACTED], England, [REDACTED]

PROPERTY VISIT DATE  
10/10/2021

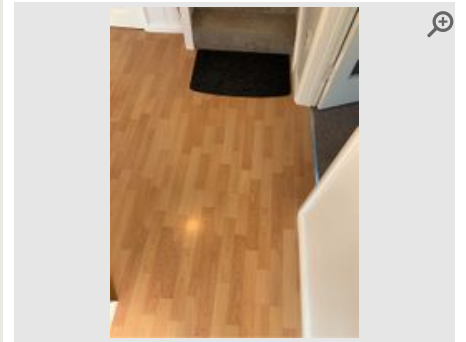
| Reference | <b>1.10.2</b> |

| 1 Entrance/Hallway | | | | |
|---|---|---|---|---|
| <b>Floor</b><br>1.10 | Laminate wood effect. Door mat present. Metal threshold strip<br>Free of stains, marks and scratches. 2 doormats. Built in doormat shows slight signs of wear. | ● Good | ● Excellent | 📷 6 photos |

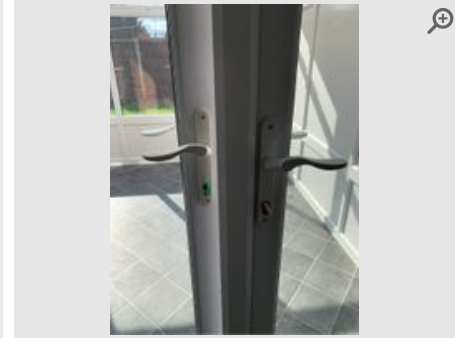
| Reference | <b>3.18.2</b> |

| Item | Description | Condition | Cleanliness | Photos |
|---|---|---|---|---|
| <b>Patio Doors</b><br>3.18 | UPVC double glazed french doors. Clear glass. Keys present. Curtain pole; wooden Exterior showing small signs of wear. Newly painted threshold panel. | ● Good | ● Excellent | 📷 6 photos |

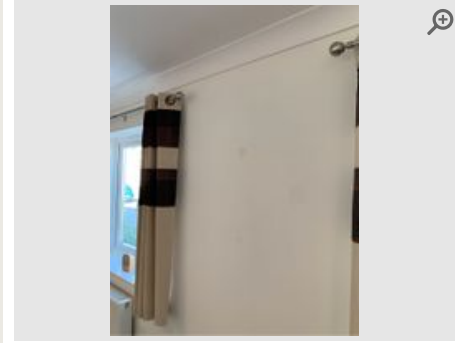
| Reference | <b>5.6.2</b> |

| Item | Description | Condition | Cleanliness | Photos |
|---|---|---|---|---|
| <b>Walls</b><br>5.6 | Plastered & painted. Plastered & painted white<br>Free of marks stains and scuffs. No picture hooks or raw plugs present. Small number of filled holes on left wall, right of bay window, between windows and above radiator. Hairline crack above radiator. | ● Good | ● Excellent | 📷 4 photos |
