# Inventory Report

3 Windsor Road, [REDACTED],  
[REDACTED], England, [REDACTED]

PROPERTY VISIT DATE  
10/10/2021

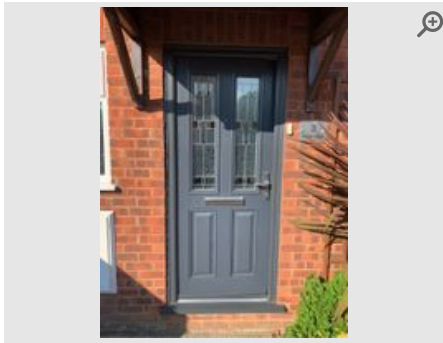
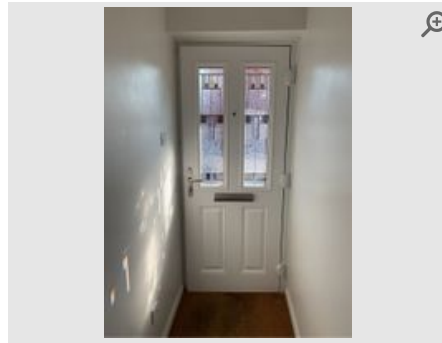
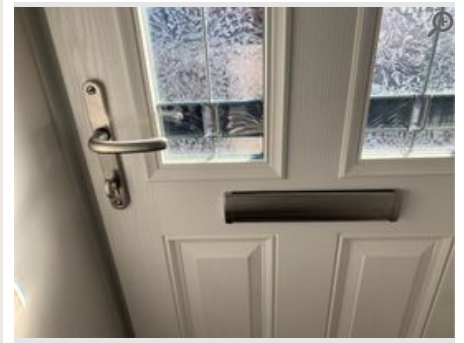
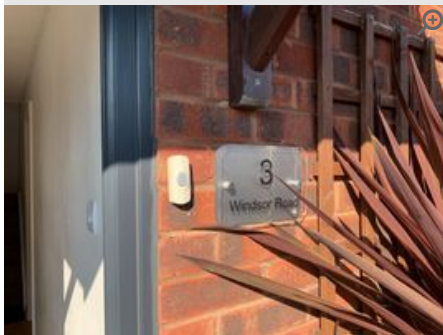
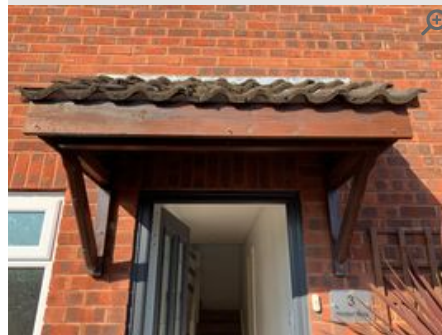
## Front Door

| 1 Entrance/Hallway | | | | |
|---|---|---|---|---|
| <b>Front Door</b><br>1.2 | Composite double glazed. Clear glass. Obscured glass. Lever handle. Brushed chrome handle. Spyhole. Integrated privacy lock. Doorbell (wireless). Chrome Letterbox. Free of marks and scratches<br>Free of marks and scratches to front side and reverse. Glazing in a good clean condition. | ● Good | ● Good | 📷 5 photos |

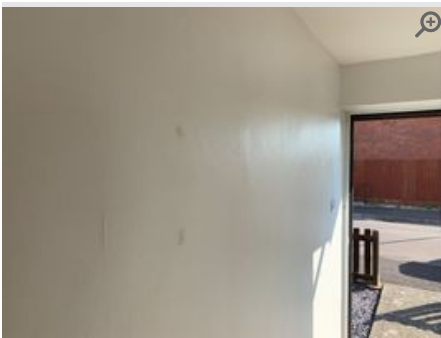
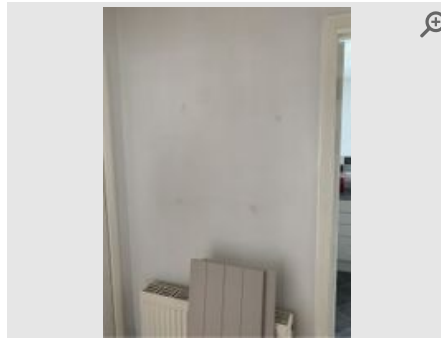
## Walls

| 1 Entrance/Hallway | | | | |
|---|---|---|---|---|
| <b>Walls</b><br>1.7 | Plastered & painted white<br>Free of marks stains and scuffs. No picture hooks or raw plugs present. Small number of filled holes on right wall and above radiator. | ● Good | ● Excellent | 📷 2 photos |

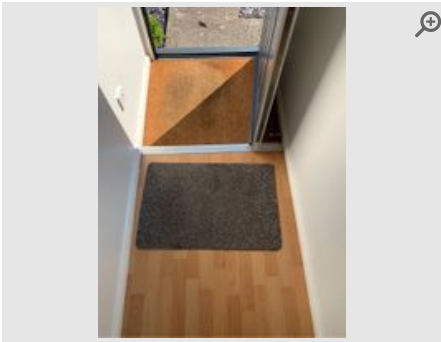
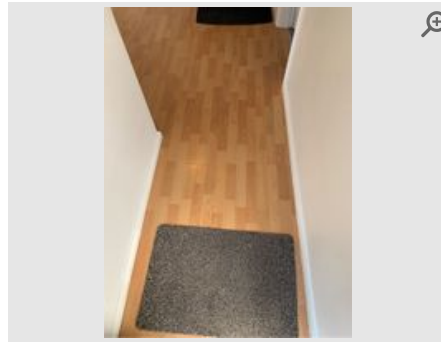
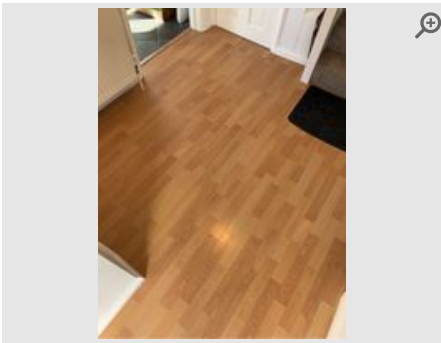
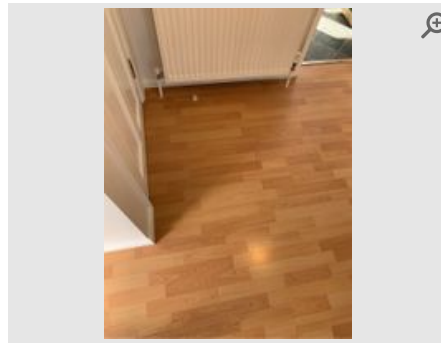
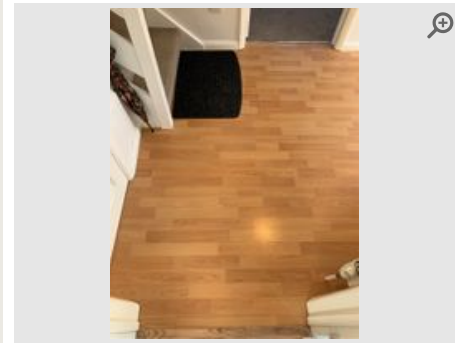
## Floor

| 1 Entrance/Hallway | | | | |
|---|---|---|---|---|
| <b>Floor</b><br>1.10 | Laminate wood effect. Door mat present. Metal threshold strip<br>Free of stains, marks and scratches. 2 doormats. Built in doormat shows slight signs of wear. | ● Good | ● Excellent | 📷 6 photos |

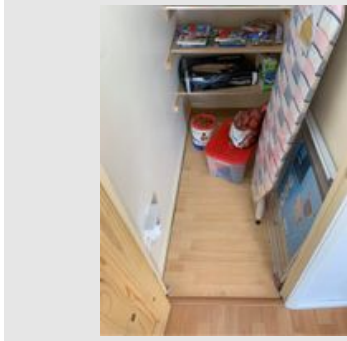
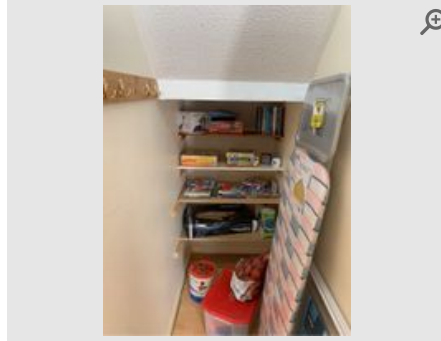
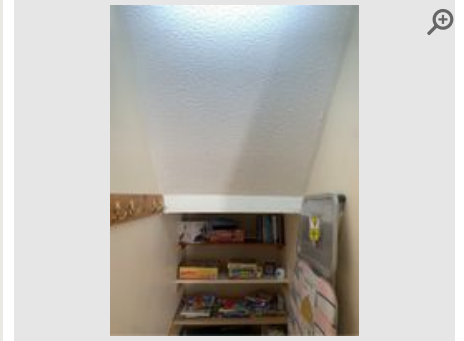
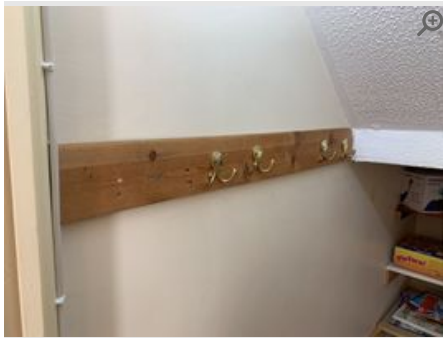
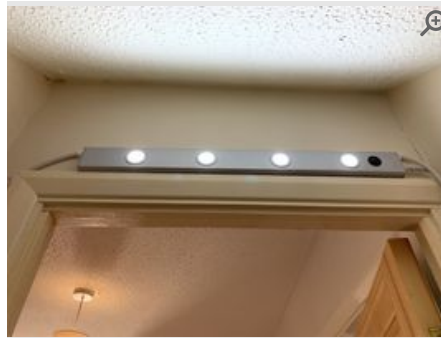
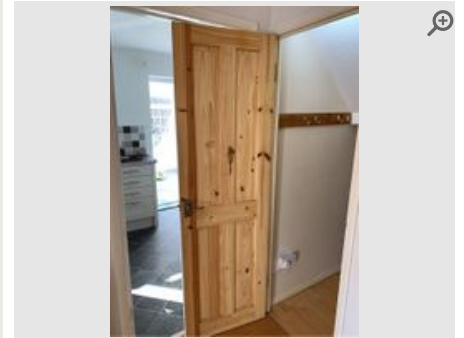
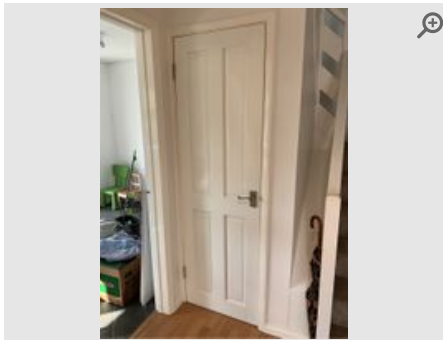
## Storage Cupboard

| 1 Entrance/Hallway | | | | |
|---|---|---|---|---|
| <b>Storage Cupboard</b><br>1.11 | Wood panelled; brushed chrome handle. White. Natural wood. Lever handle.<br>Shelving present. Miscellaneous items. Walls free of marks/stains. Floor free of marks/stains. Shelving intact. Coat hook intact<br>Under stairs cupboard. Plastered and painted walls. Coathook on left wall. Light above door. 4 shelves on rear wall. | ● Good | ● Excellent | 📷 7 photos |

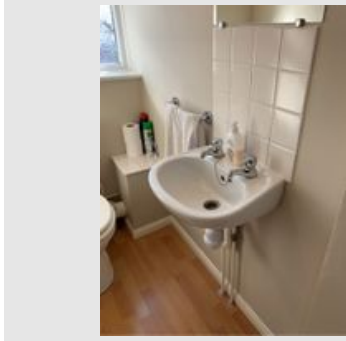
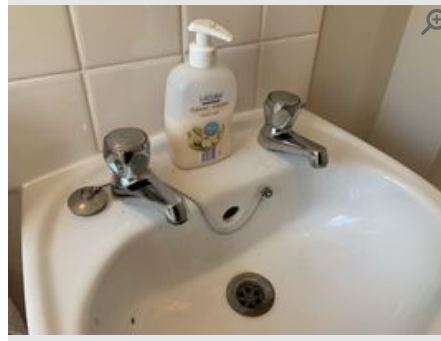
## Sink/Basin

| Item | Description | Condition | Cleanliness | Photos |
|---|---|---|---|---|
| <b>Sink/Basin</b><br>2.11 | Wall-mounted porcelain. Separate taps. Chrome taps. Plug & chain<br>Basin intact and free of cracks/chips. No gaps to sealant around edges. Clean and free of hairs. No limescale present to taps. Plug hole tarnished. | ● Fair | ● Excellent | 📷 2 photos |

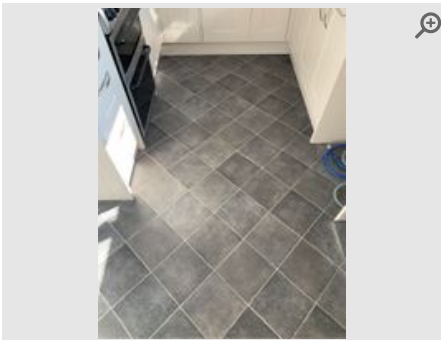
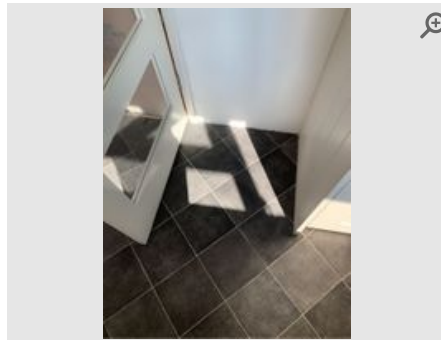
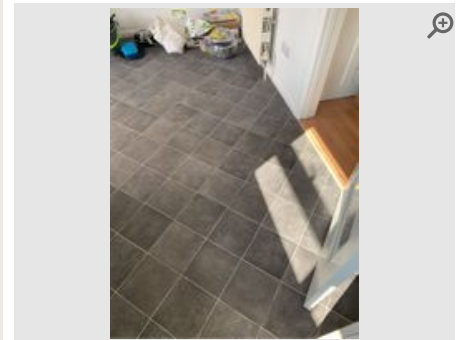
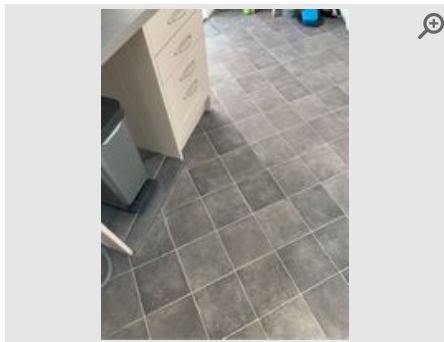
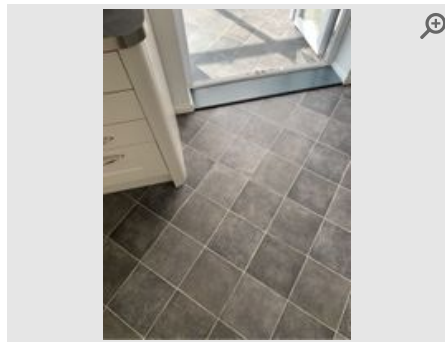
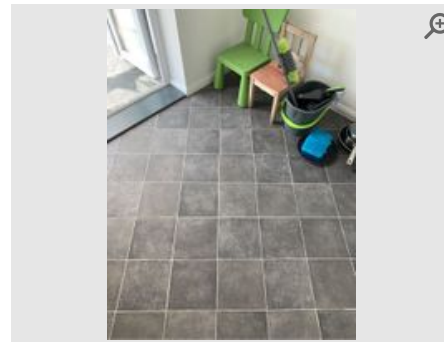
## Floor

| Item | Description | Condition | Cleanliness | Photos |
|---|---|---|---|---|
| <b>Floor</b><br>3.10 | Vinyl. Laminate threshold strip<br>Free of stains, marks and scratches. | ● Good | ● Excellent | 📷 6 photos |

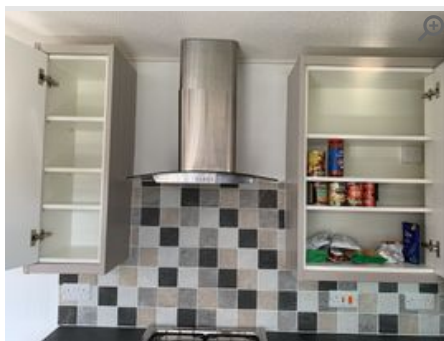
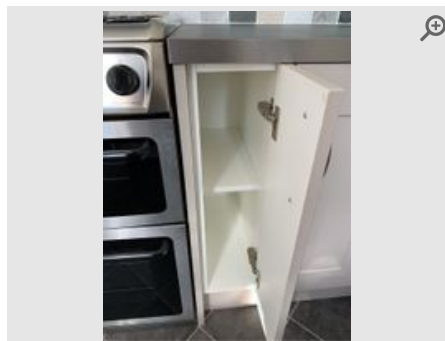
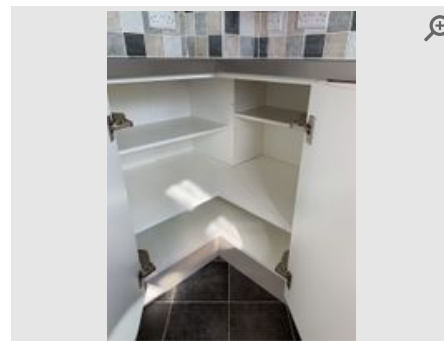
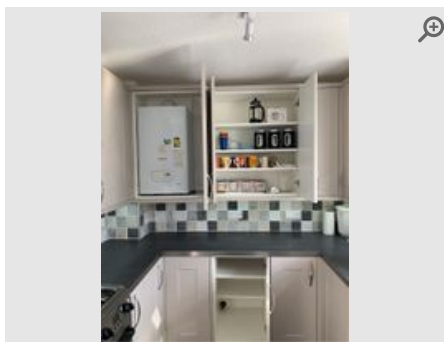
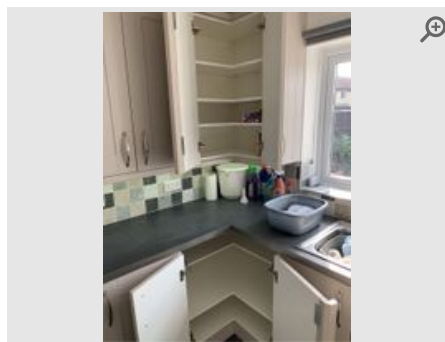
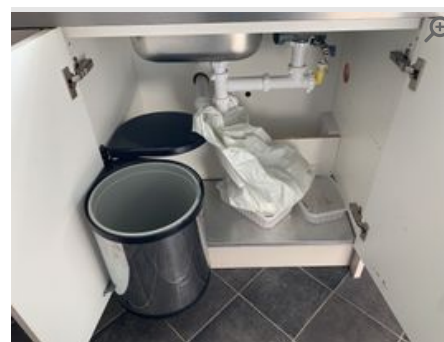
## Kitchen Cupboards/Units

| Item | Description | Condition | Cleanliness | Photos |
|---|---|---|---|---|
| <b>Kitchen Cupboards/Units</b><br>3.11 | Wall units present. Base units present. 15 hinged doors. Laminated. Fixed handles. Laminated shelving. All shelving is intact. Handles/hinges intact. Doors free of marks. Shelves free of marks. Free of grease/food residue<br>All handles and hinges intact. Free of landlord items inside, any items present are tenants. Free of stains underneath sink. Free of grease and food residue inside. | ● Good | ● Excellent | 📷 6 photos |

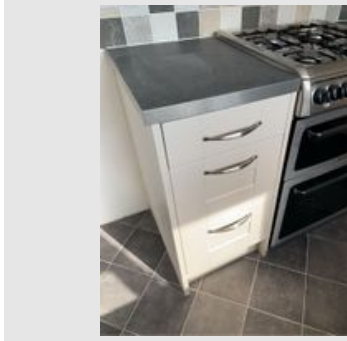
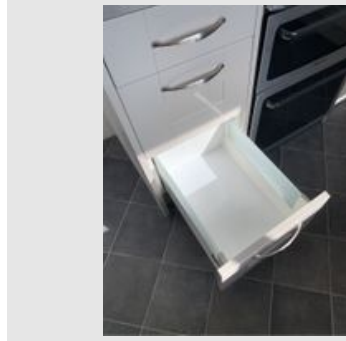
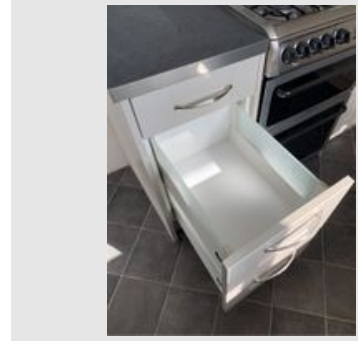
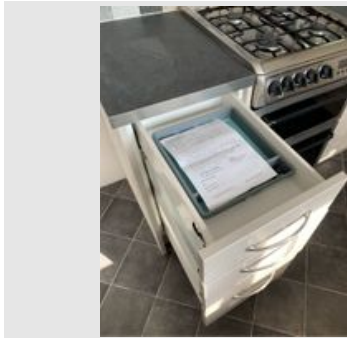
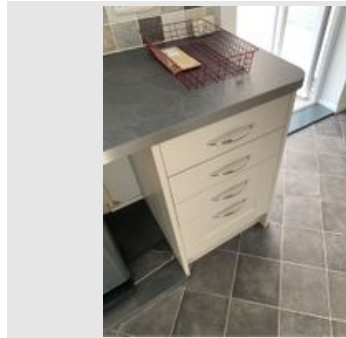
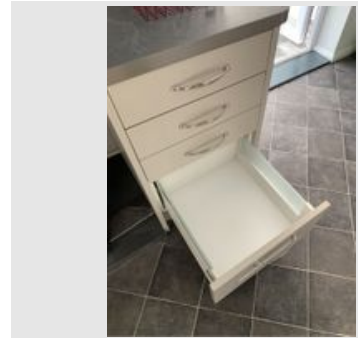
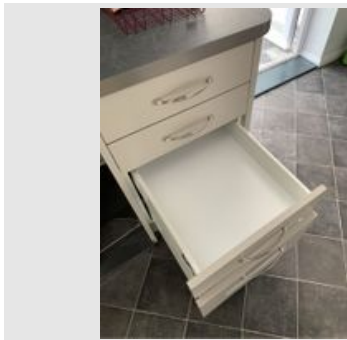
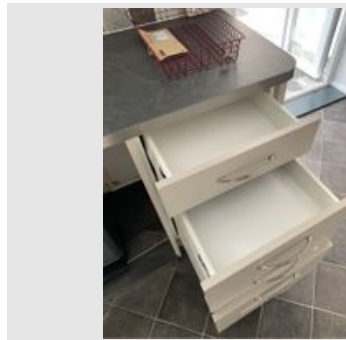
## Kitchen Drawers

| Item | Description | Condition | Cleanliness | Photos |
|---|---|---|---|---|
| <b>Kitchen Drawers</b><br>3.12 | 7 drawers. Laminated. Fixed handles. Free of marks and stains. Handles/runners intact. Free of grease/food residue<br>All handles and runners intact. Free of items inside. Free of grease and food residue inside. | ● Good | ● Excellent | 📷 8 photos |

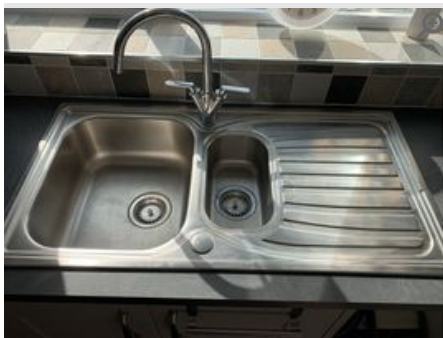
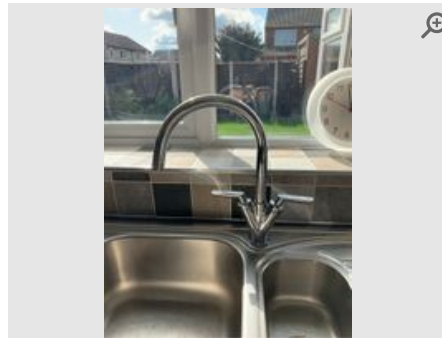
## Kitchen Sink

| Item | Description | Condition | Cleanliness | Photos |
|---|---|---|---|---|
| <b>Kitchen Sink</b><br>3.14 | Double bowl. Draining board. Stainless steel. Mixer tap. Chrome taps<br>Free of scratches and cracks. No food residue or grease present. Plug present. | ● Good | ● Excellent | 📷 2 photos |

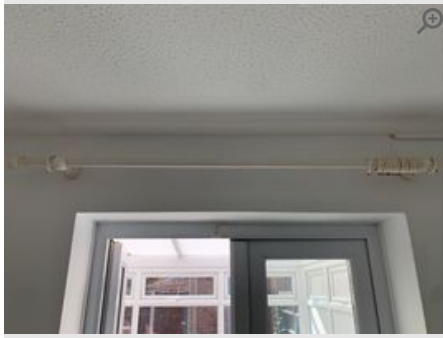
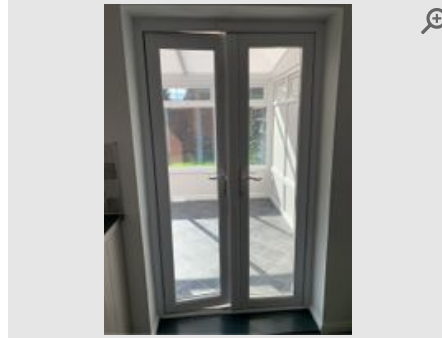
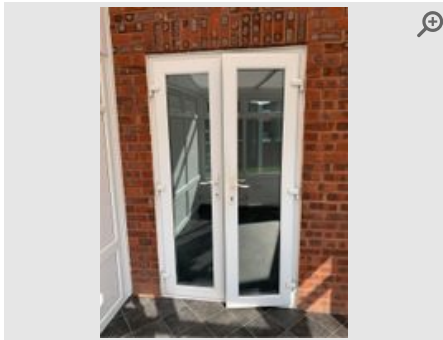
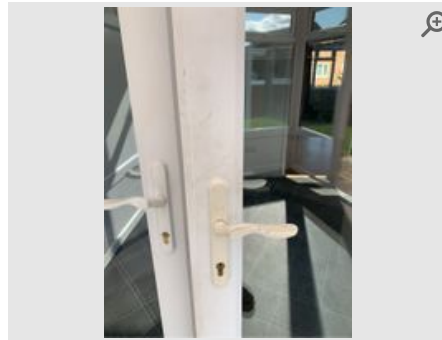
## Patio Doors

| Item | Description | Condition | Cleanliness | Photos |
|---|---|---|---|---|
| <b>Patio Doors</b><br>3.18 | UPVC double glazed french doors. Clear glass. Keys present. Curtain pole; wooden Exterior showing small signs of wear. Newly painted threshold panel. | ● Good | ● Excellent | 📷 6 photos |

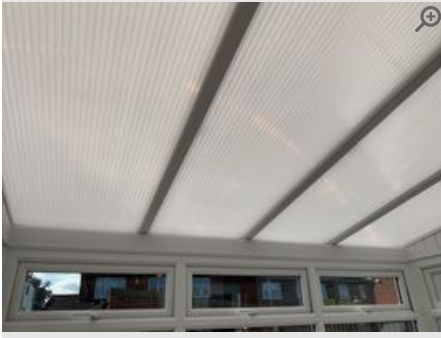
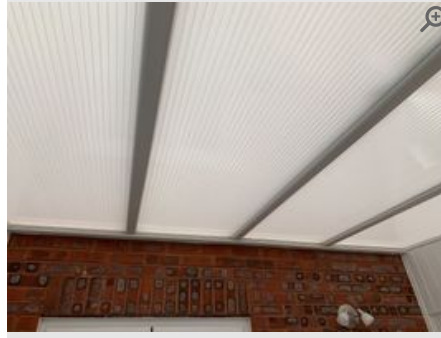
| Reference | 4.2.1 |

| Item | Description | Condition | Cleanliness | Photos |
|---|---|---|---|---|
| <b>Ceiling (conservatory)</b><br>4.2 | Plastic opaque panels. Free of marks and stains. Free of dirt/dust<br>Free of marks, mould and cobwebs. Glazing/panels intact. | ● Good | ● Excellent | 📷 2 photos |

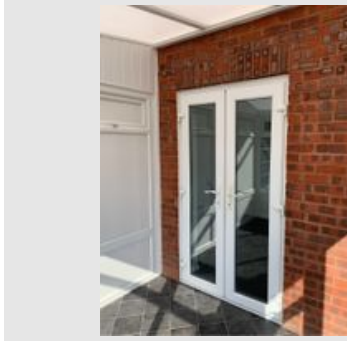
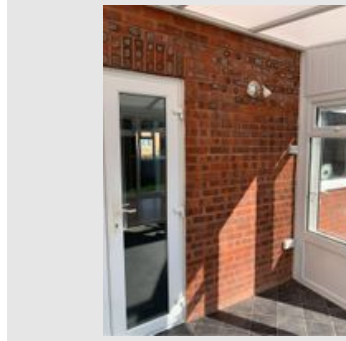
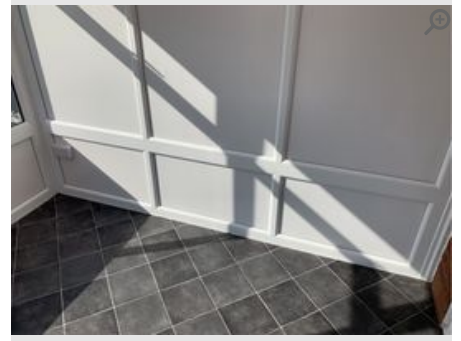
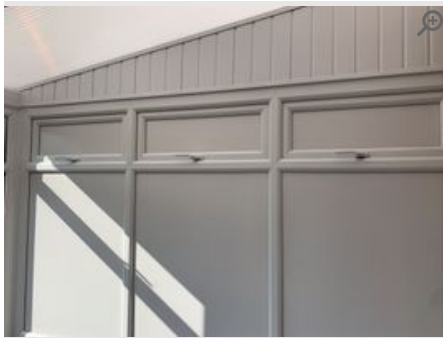
| Reference | <b>4.4.1</b> |

| Item | Description | Condition | Cleanliness | Photos |
|---|---|---|---|---|
| <b>Walls</b><br>4.4 | Exposed brickwork<br>Free of marks stains and scuffs. No picture hooks, raw plug or filled holes present.<br>UPVC wall. | ● Good | ● Excellent | 📷 4 photos |

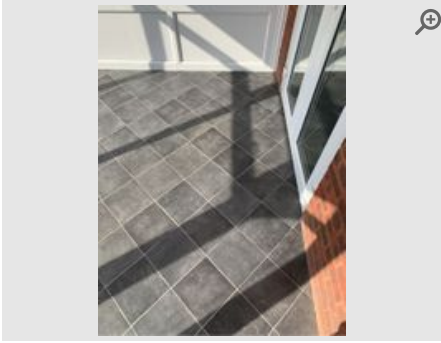
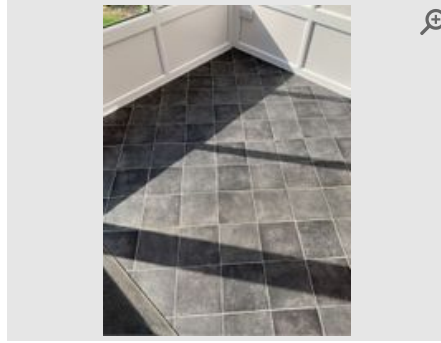
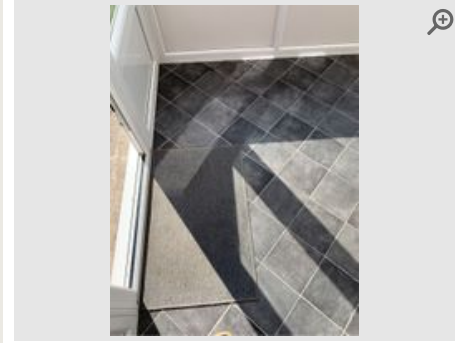
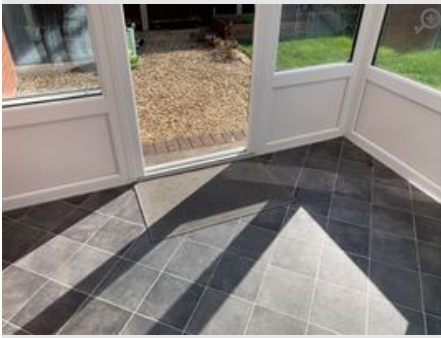
| Reference | <b>4.8.1</b> |

| Item | Description | Condition | Cleanliness | Photos |
|---|---|---|---|---|
| <b>Floor</b><br>4.8 | Vinyl. Door mat present. Free of stains. Free of marks/scratches<br>Free of stains, marks and scratches. | ● Good | ● Excellent | 📷 4 photos |

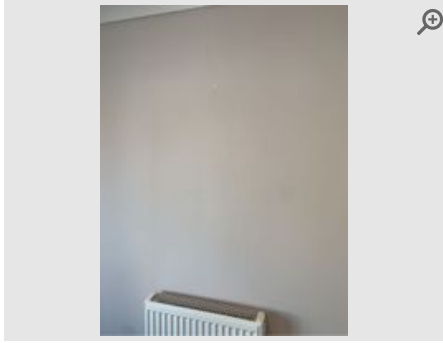
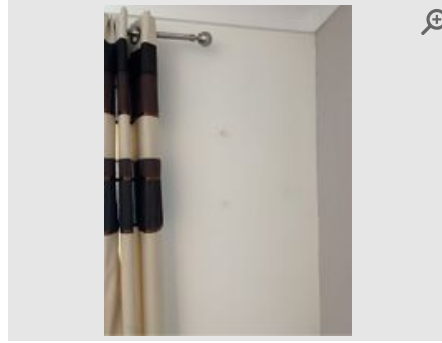
| Reference | <b>5.6.1</b> |

| Item | Description | Condition | Cleanliness | Photos |
|---|---|---|---|---|
| <b>Walls</b><br>5.6 | Plastered & painted. Plastered & painted white<br>Free of marks stains and scuffs. No picture hooks or raw plugs present. Small number of filled holes on left wall, right of bay window, between windows and above radiator. Hairline crack above radiator. | ● Good | ● Excellent | 📷 4 photos |

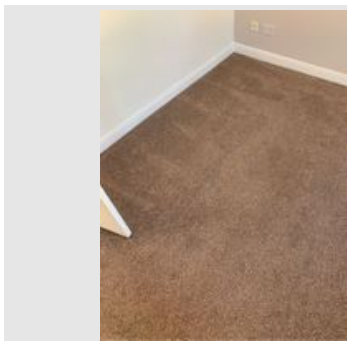
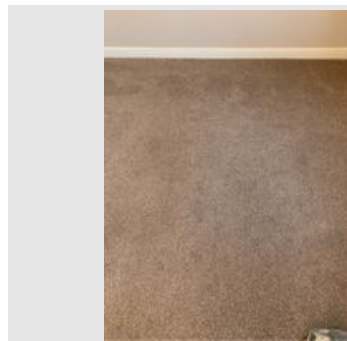
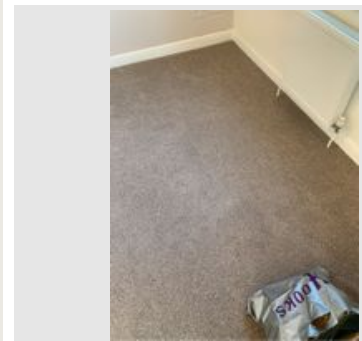
| Item | Description | Condition | Cleanliness | Photos |
|---|---|---|---|---|
| <b>Floor</b><br>5.10 | Carpeted. Metal threshold strip<br>Free of stains, marks and scratches. | ● Good | ● Excellent | 📷 6 photos |

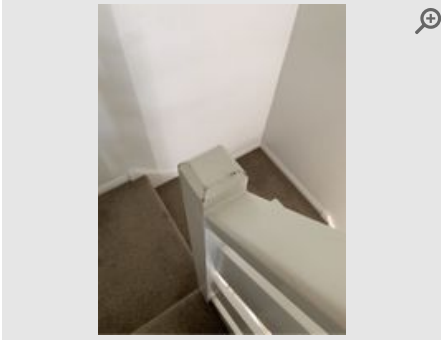
| Reference | <b>6.2.1</b> |

| Item | Description | Condition | Cleanliness | Photos |
|---|---|---|---|---|
| <b>Bannister/Hand Rail</b><br>6.2 | Wooden balustrades. Wooden handrail. Solid wood. White. Appears securely fixed<br>Appears securely fixed and intact. Free of major marks and scratches. Signs of wear in high traffic areas | ● Good | ● Excellent | 📷 1 photo |

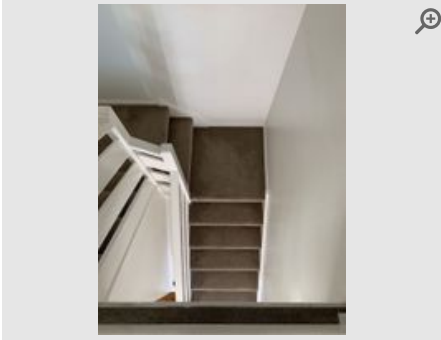
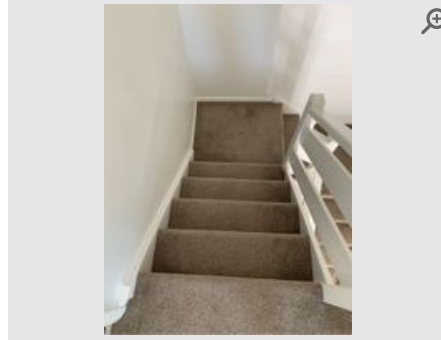
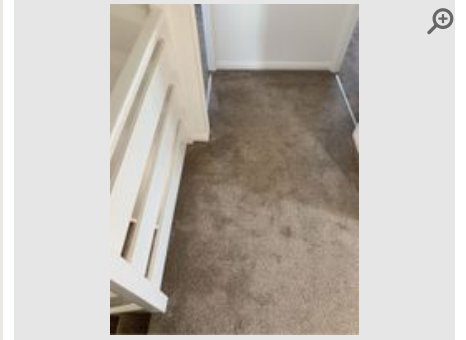
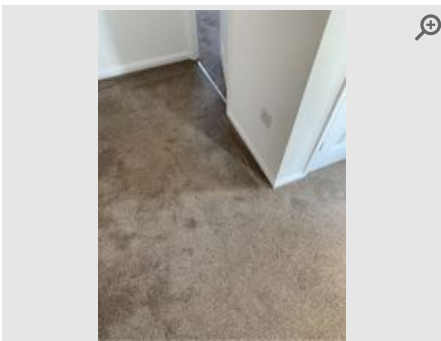
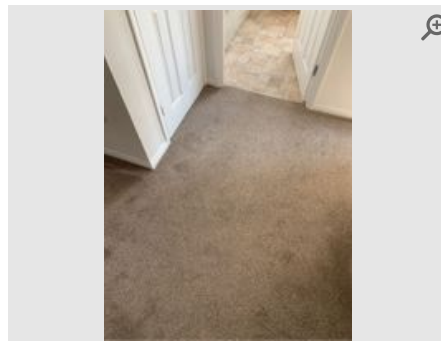
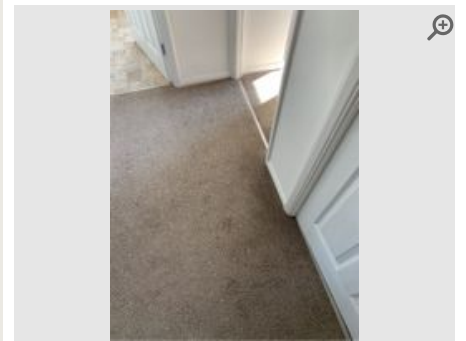
| Item | Description | Condition | Cleanliness | Photos |
|---|---|---|---|---|
| <b>Floor</b><br>6.3 | Carpeted<br>Free of stains, marks and scratches. | ● Good | ● Excellent | 📷 6 photos |

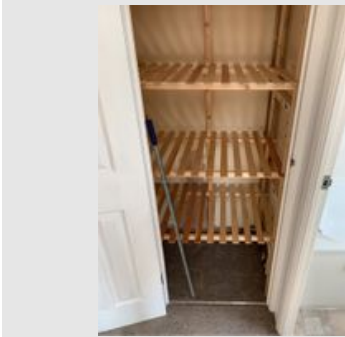
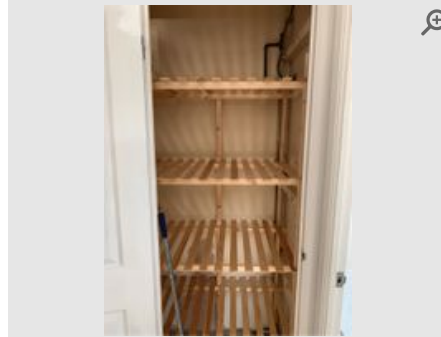
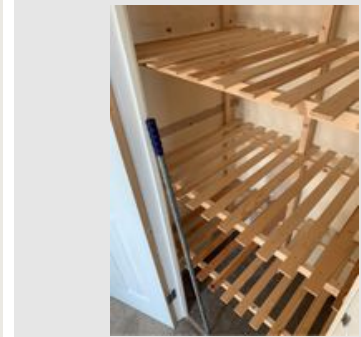
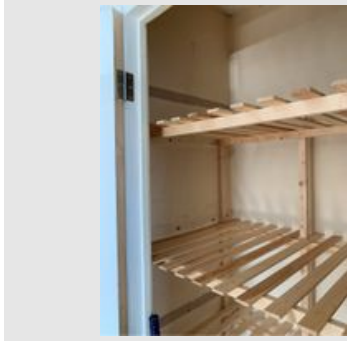
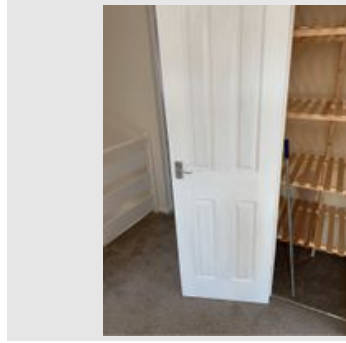
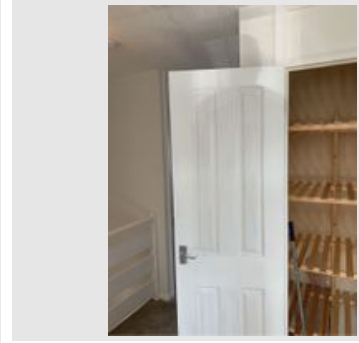
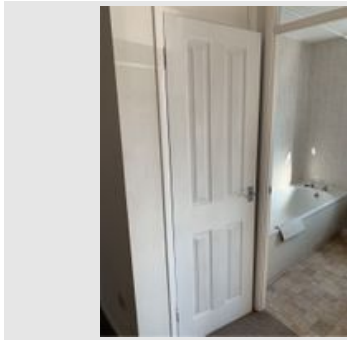
| Item | Description | Condition | Cleanliness | Photos |
|---|---|---|---|---|
| <b>Storage Cupboard</b><br>6.11 | Wood panelled; chrome handle. White. Free of marks/stains. Shelving present.<br>Walls free of marks/stains. Floor free of marks/stains. Shelving intact<br>Free of marks and scratches to front side and reverse of door. Free of items and rubbish inside. | ● Good | ● Excellent | 📷 7 photos |

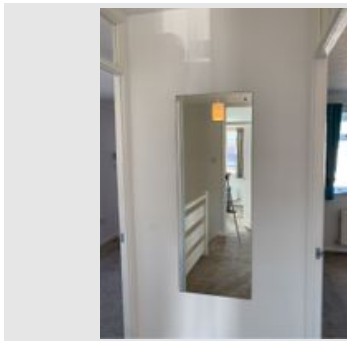
| Item | Description | Condition | Cleanliness | Photos |
|---|---|---|---|---|
| <b>Wall Mirror</b><br>6.12 | Wall-mounted rectangular. Free of marks. No cracks/chips. Free of dirt/dust | ● Good | ● Excellent | 📷 1 photo |

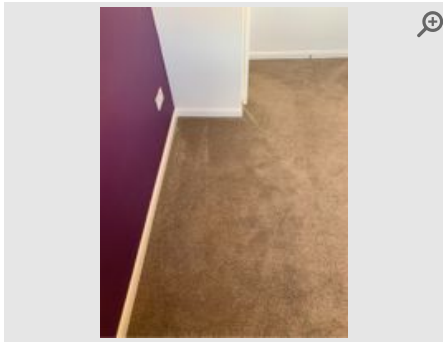
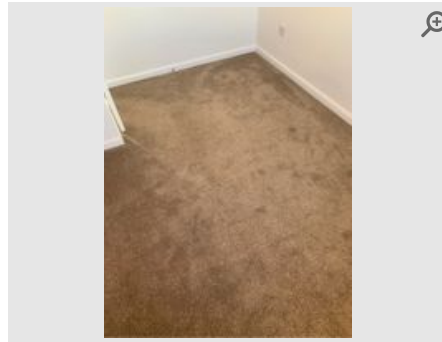
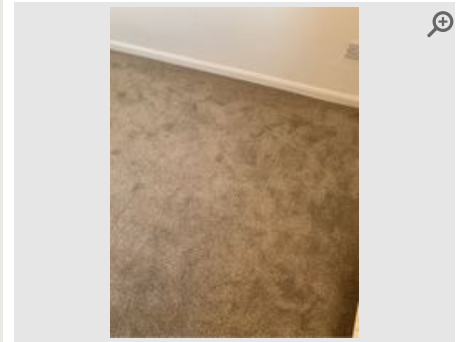
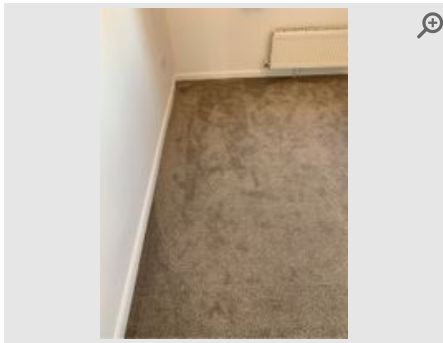
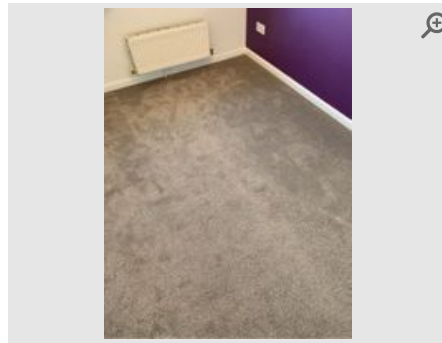
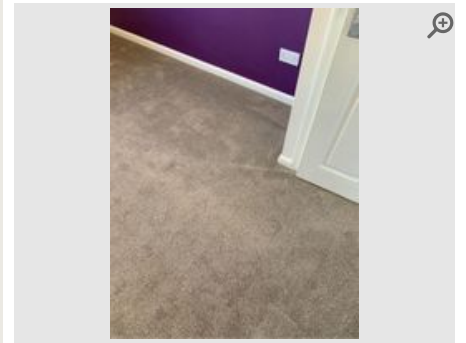
| Item | Description | Condition | Cleanliness | Photos |
|---|---|---|---|---|
| <b>Floor</b><br>7.10 | Carpeted<br>Free of stains, marks and scratches. | ● Good | ● Excellent | 📷 6 photos |

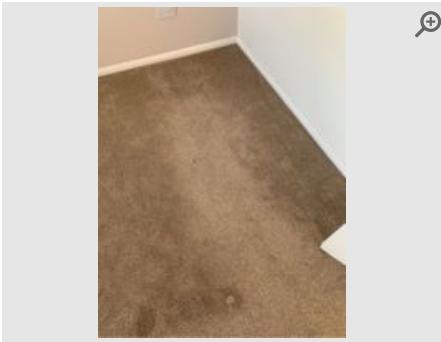
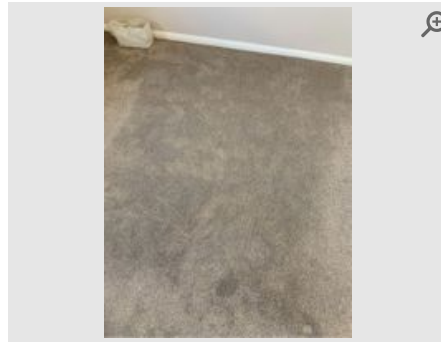
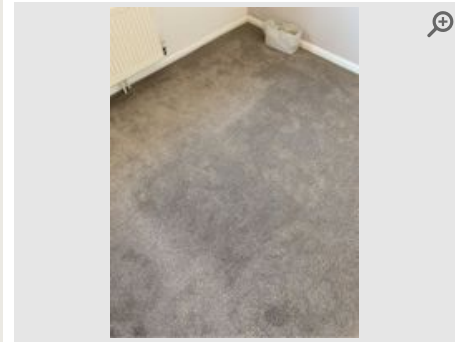
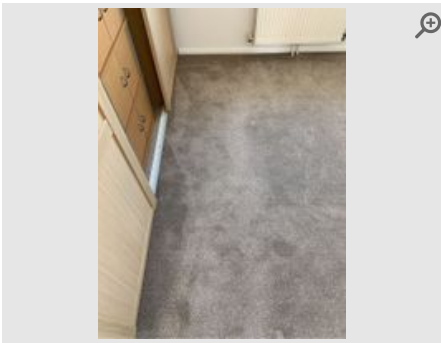
| Item | Description | Condition | Cleanliness | Photos |
|---|---|---|---|---|
| <b>Floor</b><br>8.10 | Carpeted. Metal threshold strip<br>Free of stains, marks and scratches. | ● Good | ● Excellent | 📷 4 photos |

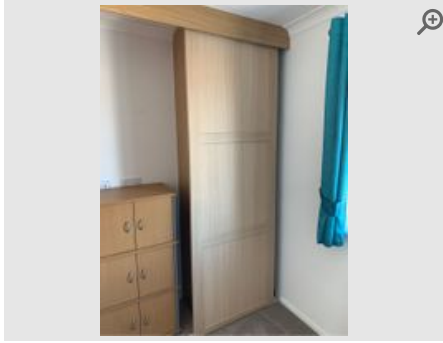
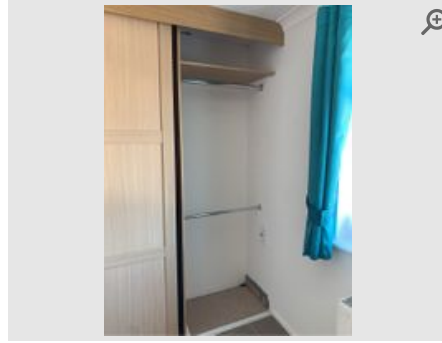
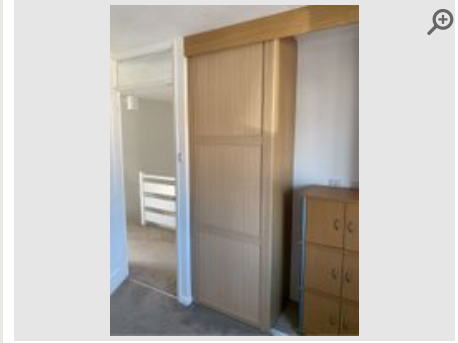
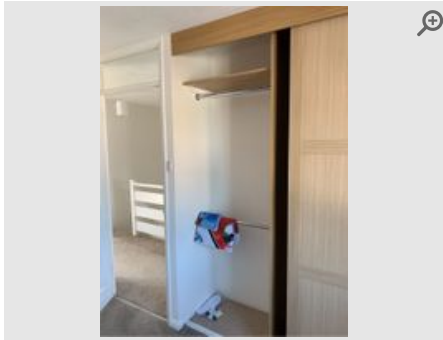
| Item | Description | Condition | Cleanliness | Photos |
|---|---|---|---|---|
| <b>Storage Cupboard/Wardrobe</b><br>8.11 | Built-in. Wood panelled. Free of marks/stains. Rail present. Shelving present<br>Free of marks and scratches to front side and reverse of door. Door runner intact.<br>Free of items and rubbish inside. | ● Good | ● Excellent | 📷 4 photos |

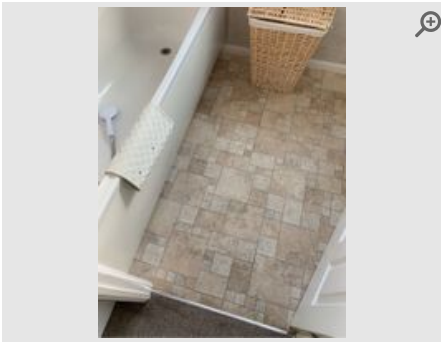
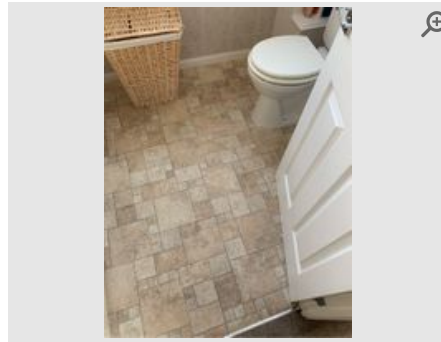
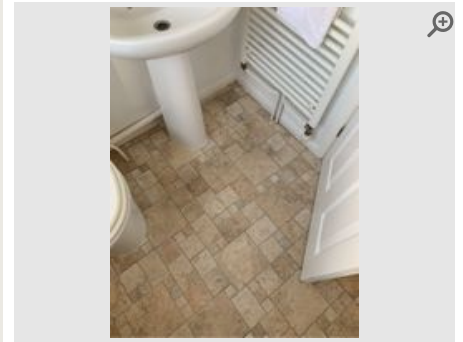
| Item | Description | Condition | Cleanliness | Photos |
|---|---|---|---|---|
| <b>Floor</b><br>9.11 | Vinyl<br>Free of stains, marks and scratches. Tile effect. | ● Good | ● Excellent | 📷 3 photos |

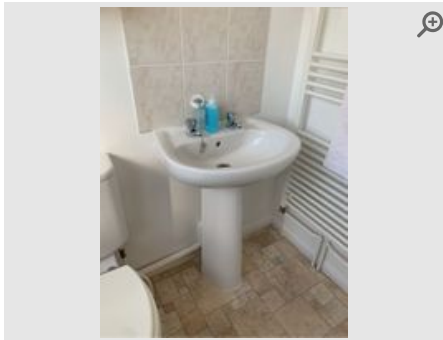
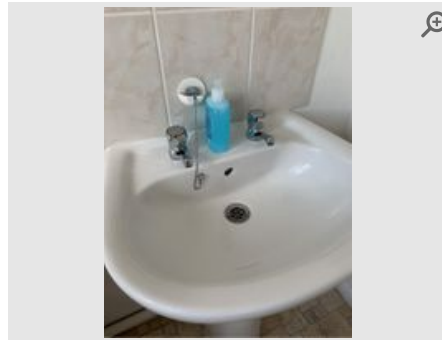
| Item | Description | Condition | Cleanliness | Photos |
|---|---|---|---|---|
| <b>Sink/Basin</b><br>9.14 | Pedestal porcelain. Separate taps. Chrome taps. Plug & chain<br>Basin intact and free of cracks/chips. No gaps to sealant around edges. Clean and free of hairs. No limescale present to taps. | ● Good | ● Excellent | 📷 2 photos |

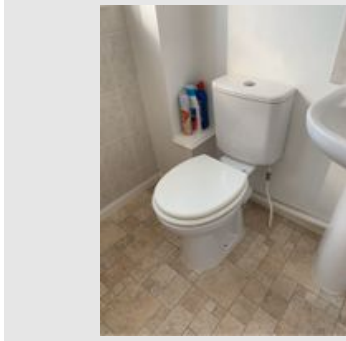
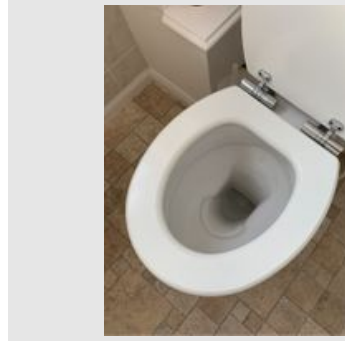
| Item | Description | Condition | Cleanliness | Photos |
|---|---|---|---|---|
| <b>Toilet</b><br>9.15 | Porcelain. Coated wooden seat & lid. Flush button<br>Free of cracks/chips. Flush intact. Seat secure and intact. Clean inside and to tank/base. | ● Good | ● Excellent | 📷 2 photos |

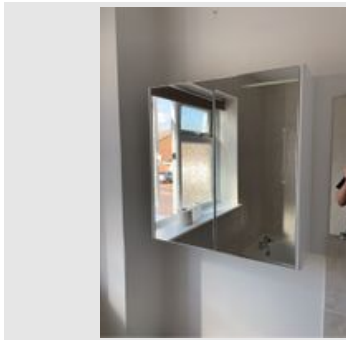
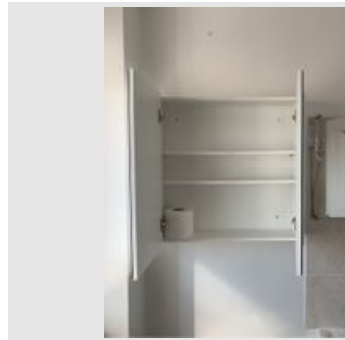
| Item | Description | Condition | Cleanliness | Photos |
|---|---|---|---|---|
| <b>Cabinet</b><br>9.16 | 2 hinged doors. 3 shelves. Laminate. Mirrored<br>Securely fixed to wall. Free of soiling/stains inside. Free of items inside. Hinges functioning well. | ● Good | ● Excellent | 📷 2 photos |

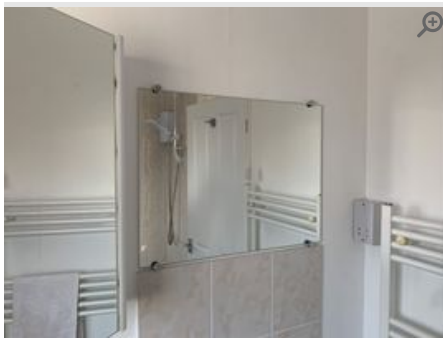
| Item | Description | Condition | Cleanliness | Photos |
|---|---|---|---|---|
| <b>Mirror</b><br>9.17 | Wall-mounted rectangular. Free of marks. No cracks/chips. Free from smears<br>Wall-mounted and securely fixed. No cracks/chips. Free of smears and dust. | ● Good | ● Excellent | 📷 1 photo |

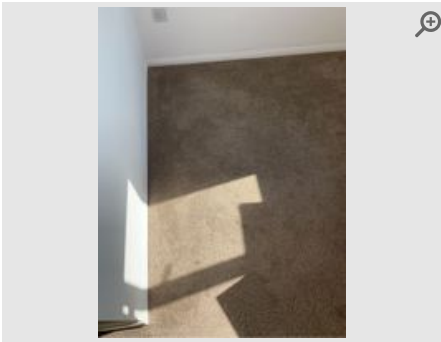
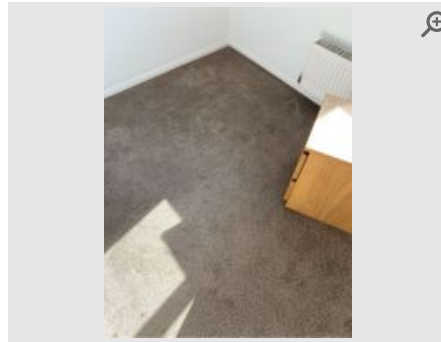
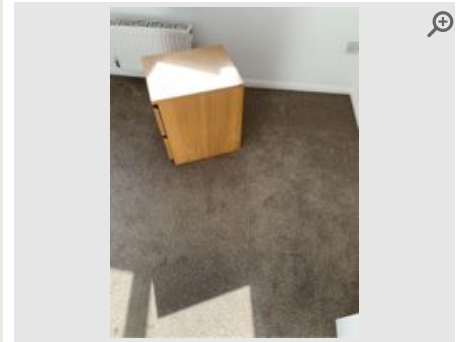
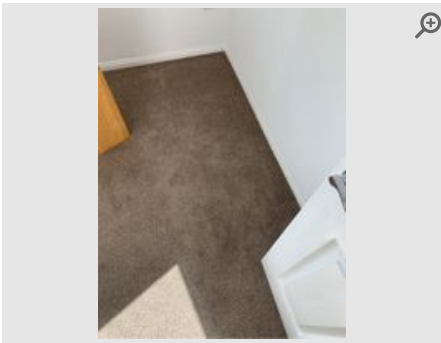
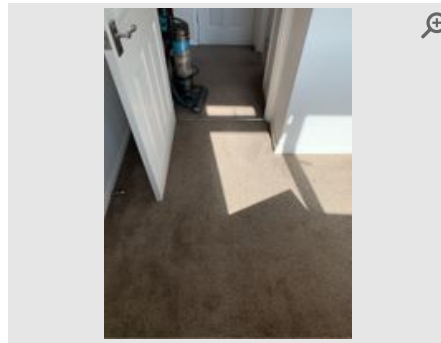
## Floor

| Item | Description | Condition | Cleanliness | Photos |
|---|---|---|---|---|
| <b>Floor</b><br>10.10 | Carpeted<br>Free of stains, marks and scratches. | ● Good | ● Excellent | 📷 5 photos |

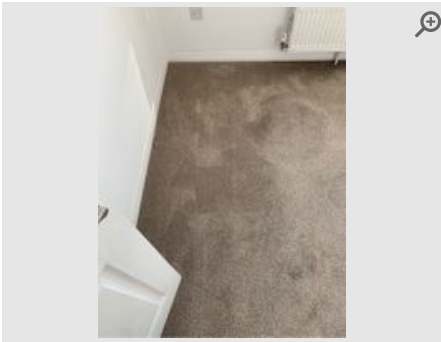
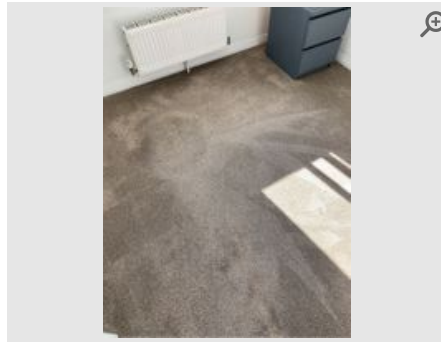
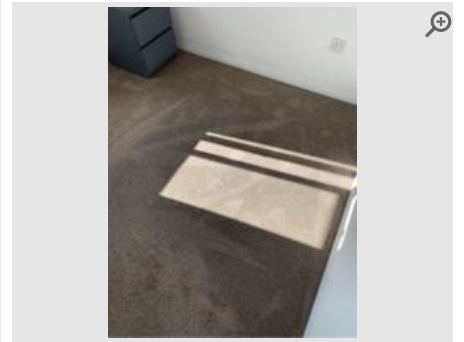
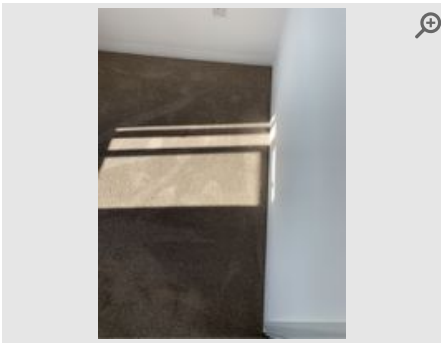
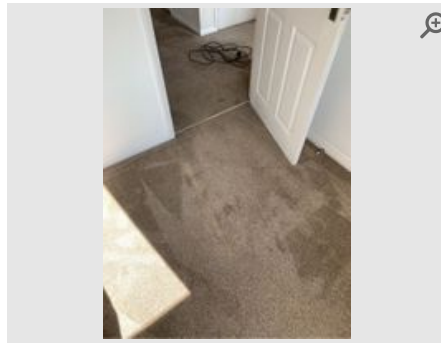
## Floor

| Item | Description | Condition | Cleanliness | Photos |
|---|---|---|---|---|
| <b>Floor</b><br>11.10 | Carpeted<br>Free of stains, marks and scratches. | ● Good | ● Excellent | 📷 5 photos |
